Inspector's Daily Report

IDR Sheet	1	of	2	Sheets
Contract	Day				Date
C7852	Wednesday				August 10, 2011

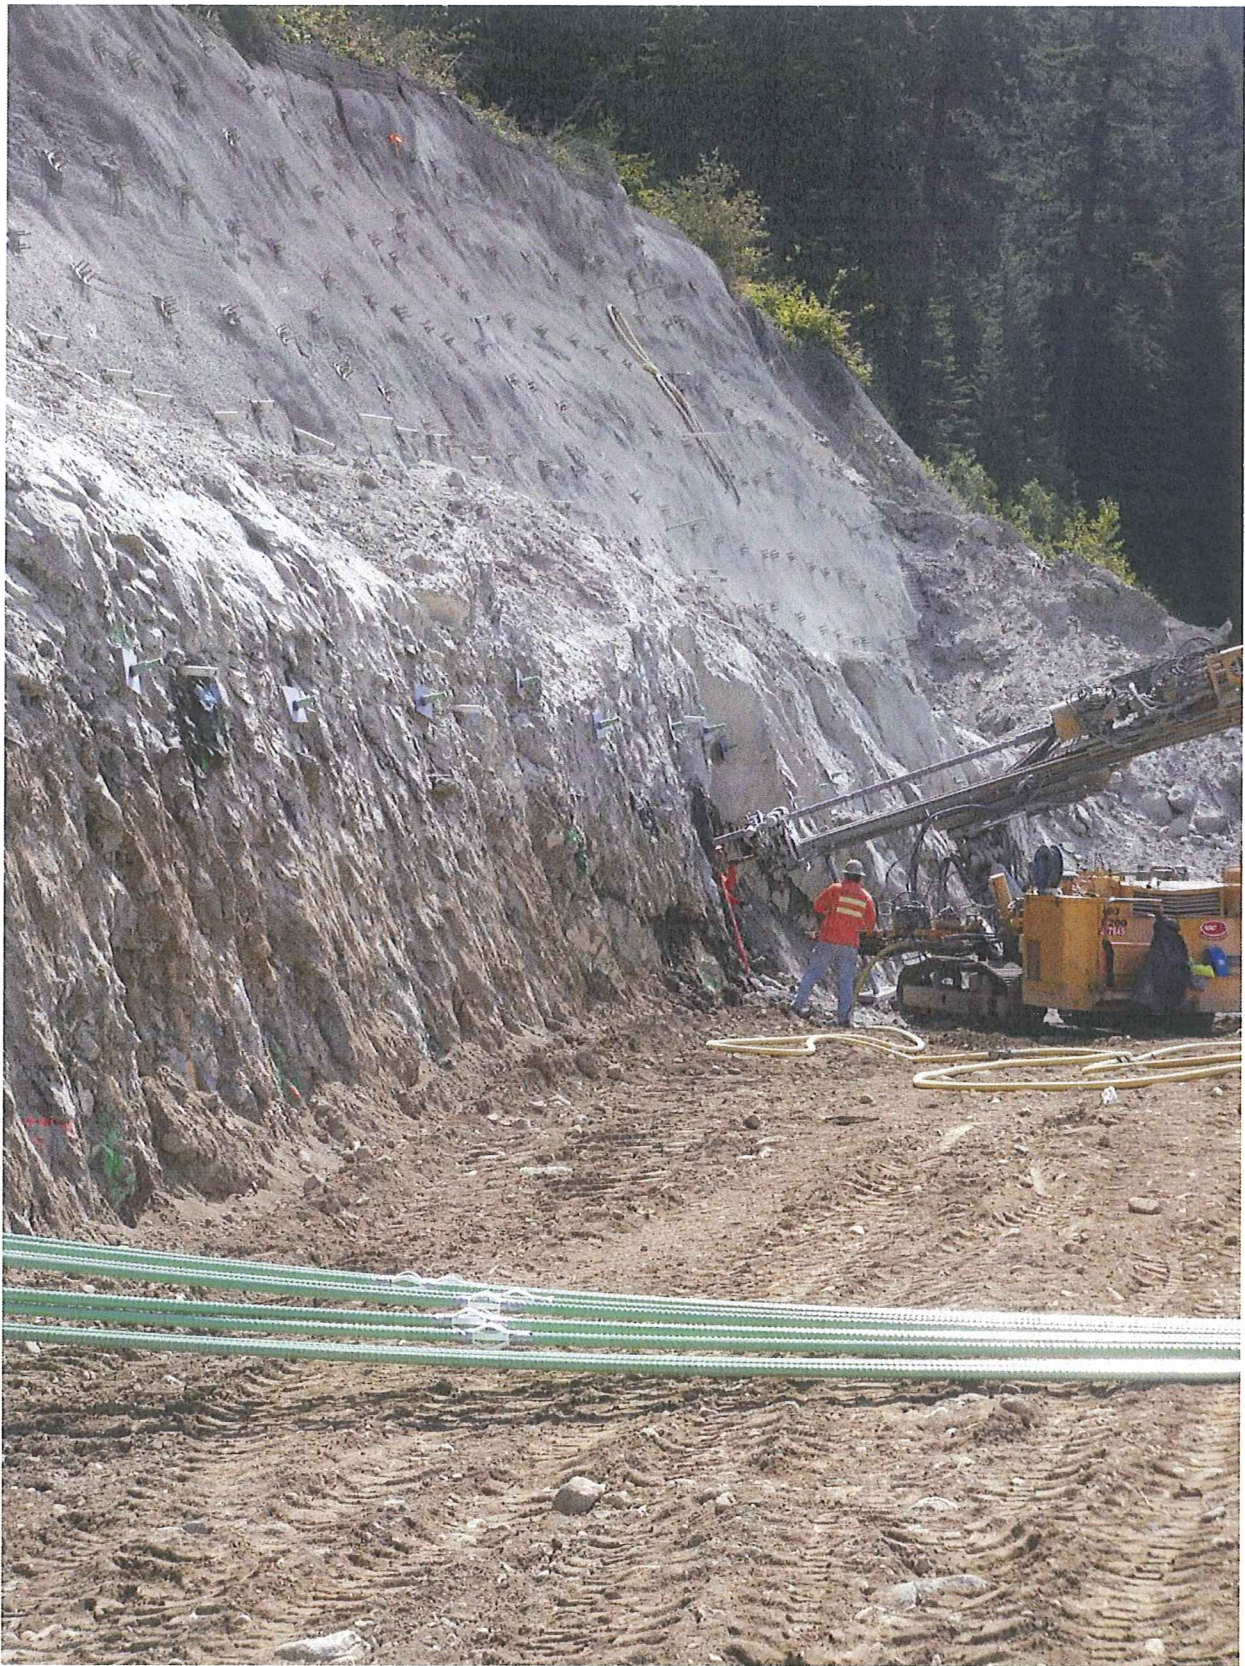
From approximately Sta. 1346+00 to 1348+00, the preshear line, containing half-rounds every 12 inches or so, was in good condition (Figure 1). There were some drill holes that will not meet deviation specifications for the drilling of controlled blast holes, but overall, there did not appear to be any overbreak (hot zones) or back break (cold zones) in this section (Figure 2). From LW Sta. 1348+00 to 1349+00, the preshear line was apparent in the lower portion of the approximately 10 foot high lift, but there were significant rock blocks that were missing from the slope face (Figure 3). I inquired with Mike Mulhern whether the missing blocks were a product of overbreak or back break, and he indicated that there were several dialated blocks that they (Eric Smith and him) chose to remove with scaling rather than reinforce. He didn't feel that the blasting created the dialated blocks. During my evaluation, I did not see any evidence of excessive use of explosives in the lower half-rounds (no radial cracking back into the slope).

Figure 1. An oblique photograph of the recently exposed preshear line from approximately LW Sta. 1347+00 to 1348+00. The drill rig is setup at LW Sta. 1348+00.

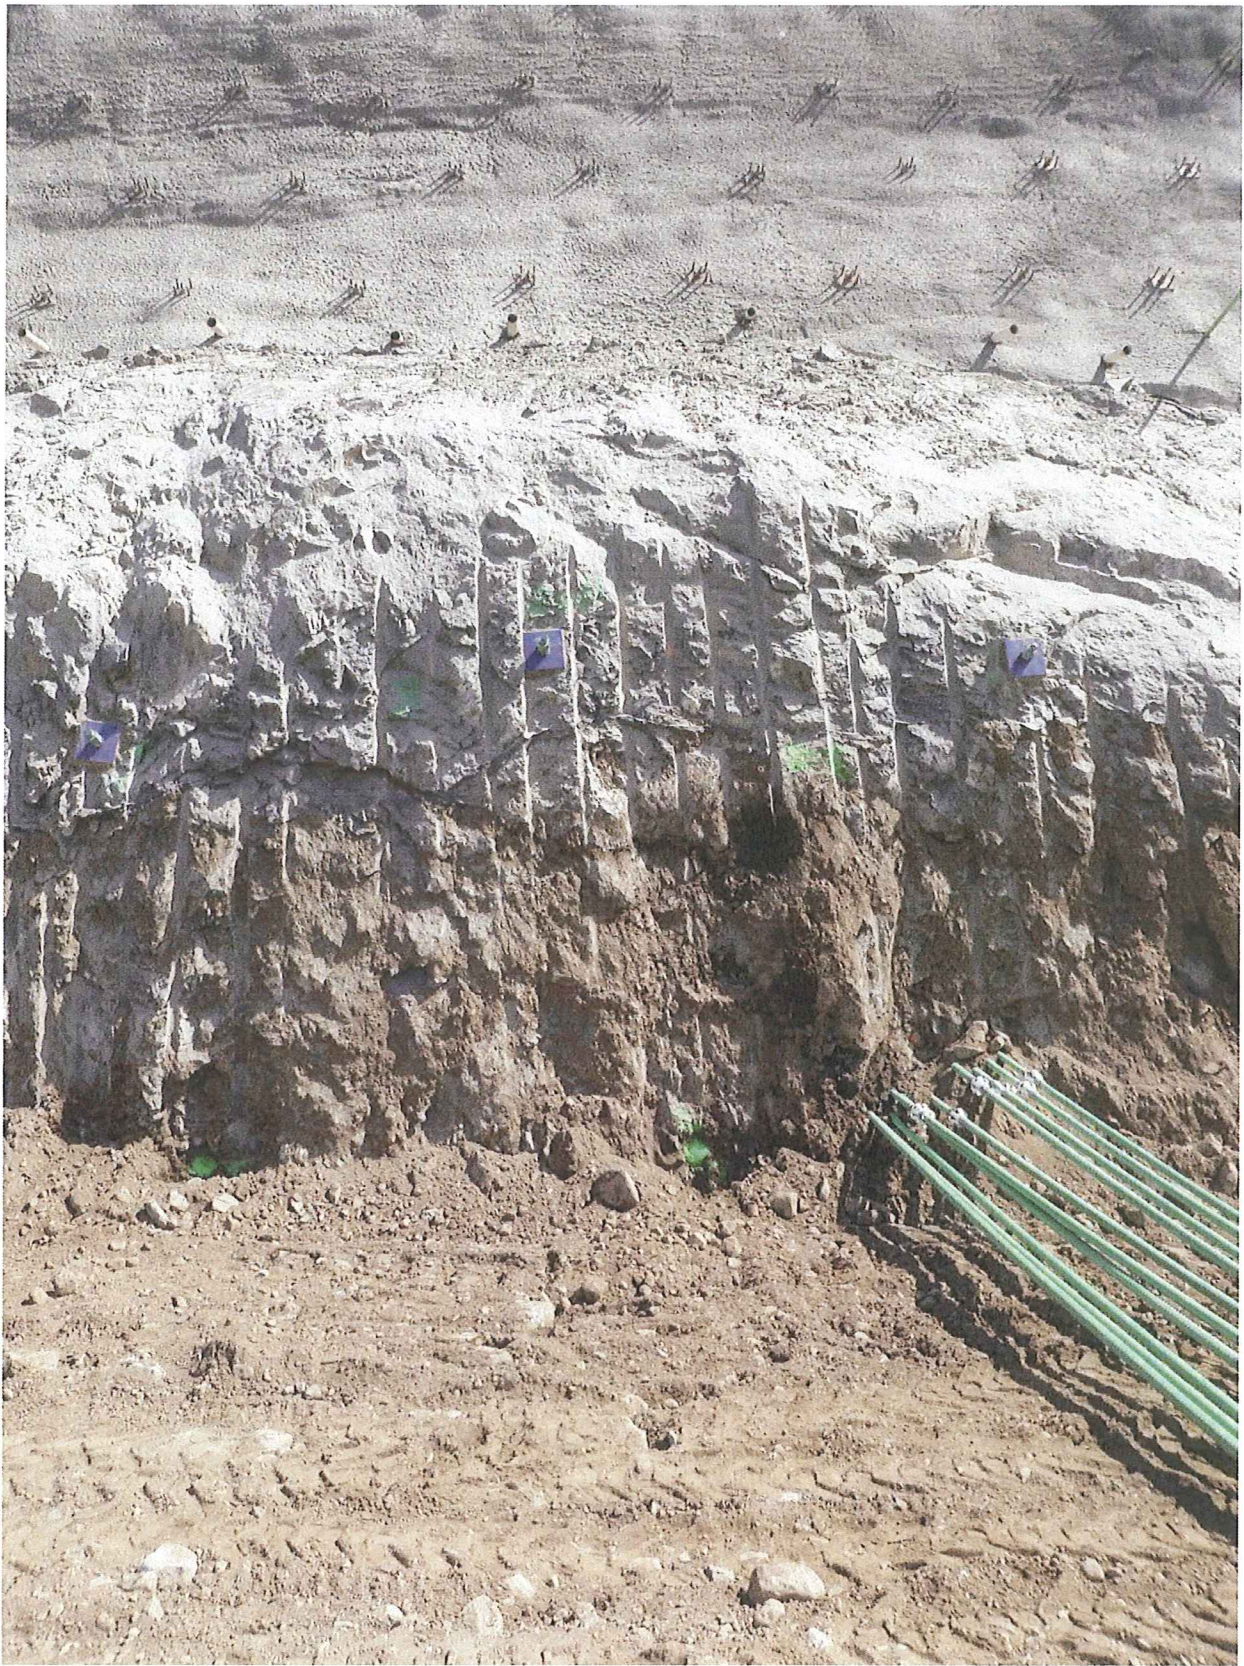
Figure 2. A close-up photograph of the preshear at approximately LW Sta. 1347+50.

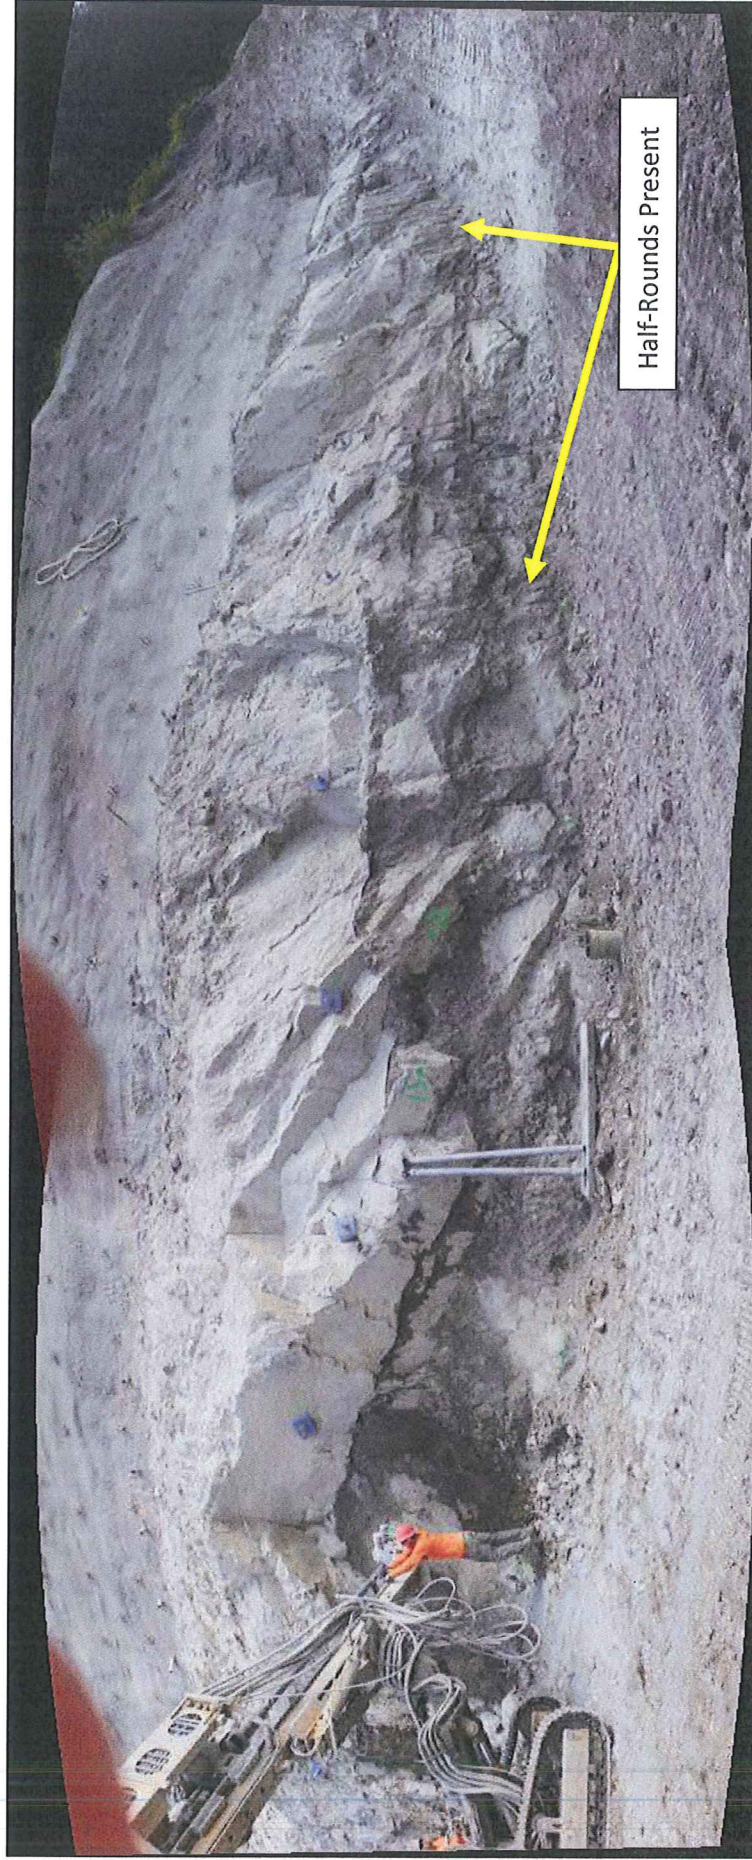
Figure 3. A panoramic photograph of the preshear line below the soil nail wall between approximately LW Sta. 1348+00 to 1349+00. Notice the preshear half-rounds toward the east end of the recent excavation.

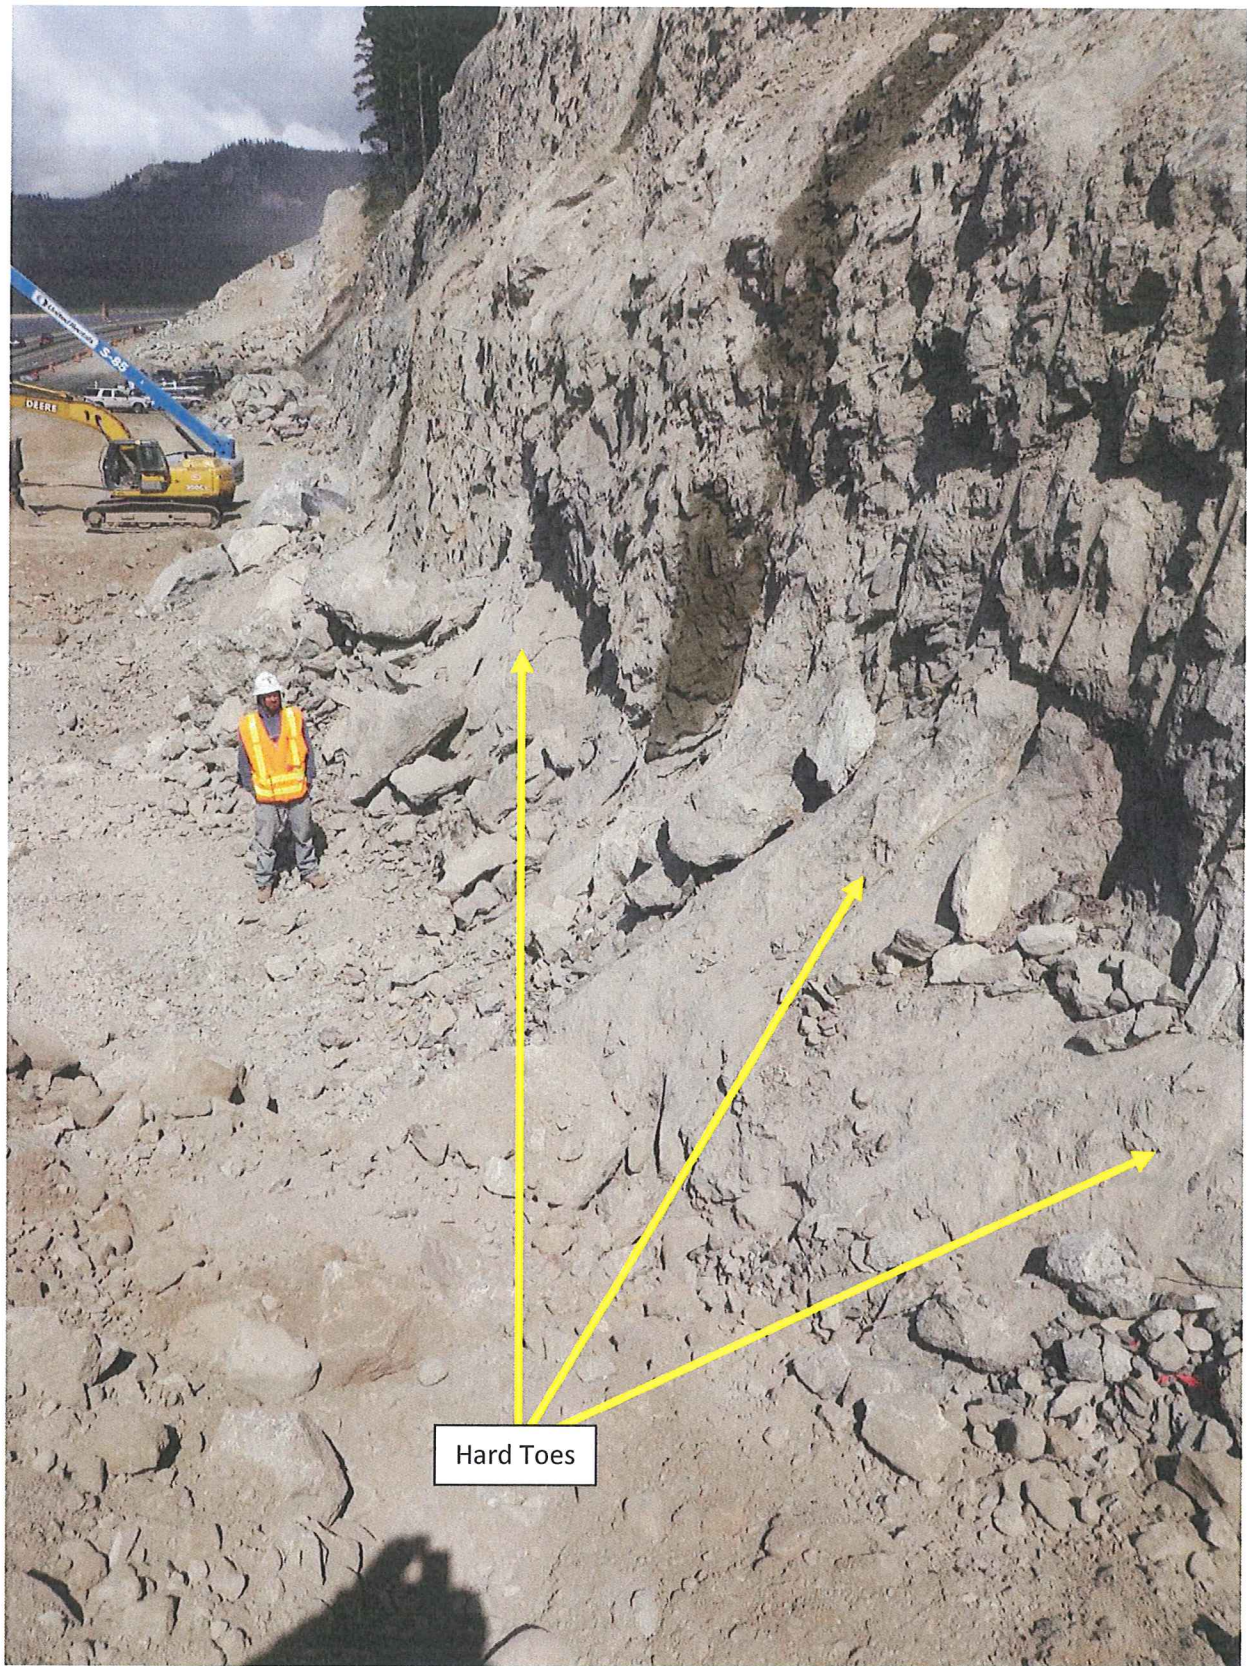
Around 11:45 am, as we were walking back to the west, I noticed a series of hard toes near the base of the slope from approximately LW Sta. 1345+50 to 1343+50 (Figure 4). Brad Collier, Western States Blaster-In-Charge, approached us as we were looking at the hard toe areas. He indicated that they had recently re-shot those hard toes and KLB has not had a chance to try and remove them. He showed us that there were small cracks between the reshot preshear holes. They couldn't be seen unless you were right on top of them. Brad did not seem overly concerned about the hard toes and remarked that he didn't think they were going to be a problem.

Figure 4. A photograph looking from approximately LW Sta. 1345+50 to 1343+50 at a series of hard toes. These hard toes have been reshot but the Contractor has not attempted to remove the toes yet.

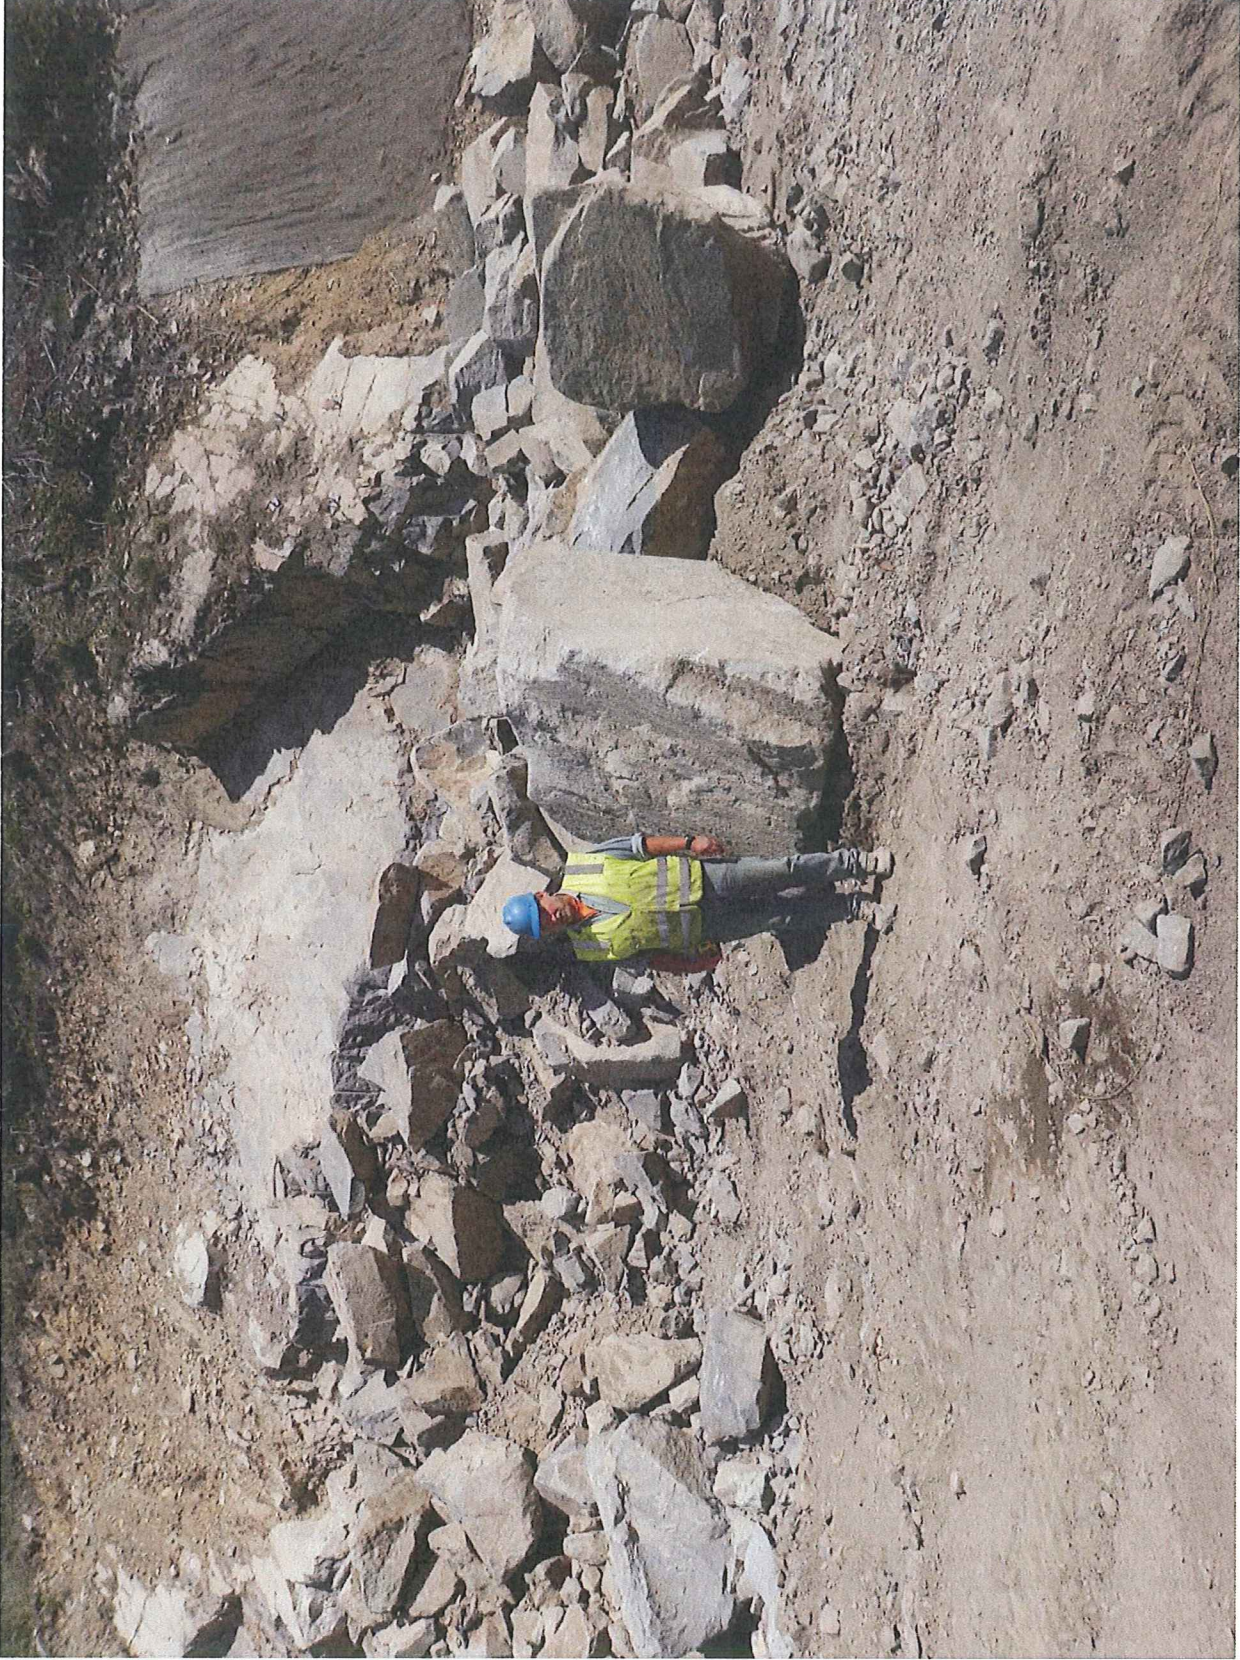
We continued to the west and stopped at the large pile of oversized rocks that KLB has been separating out of the muck at the base of Jenkin's Knob near LW Sta. 1340+00 (Figure 5). I asked if Brad C. was happy with the amount of oversized, and he said that the oversized was being generated at the outside edge of the existing cut and in the upper 4 to 8 feet of the production shots where the stemming is. He told us that he was happy with the fragmentation of the production shots.

Figure 5. A photograph near LW Station 1340+00 of the oversized material that has been stockpiled from the blasting.

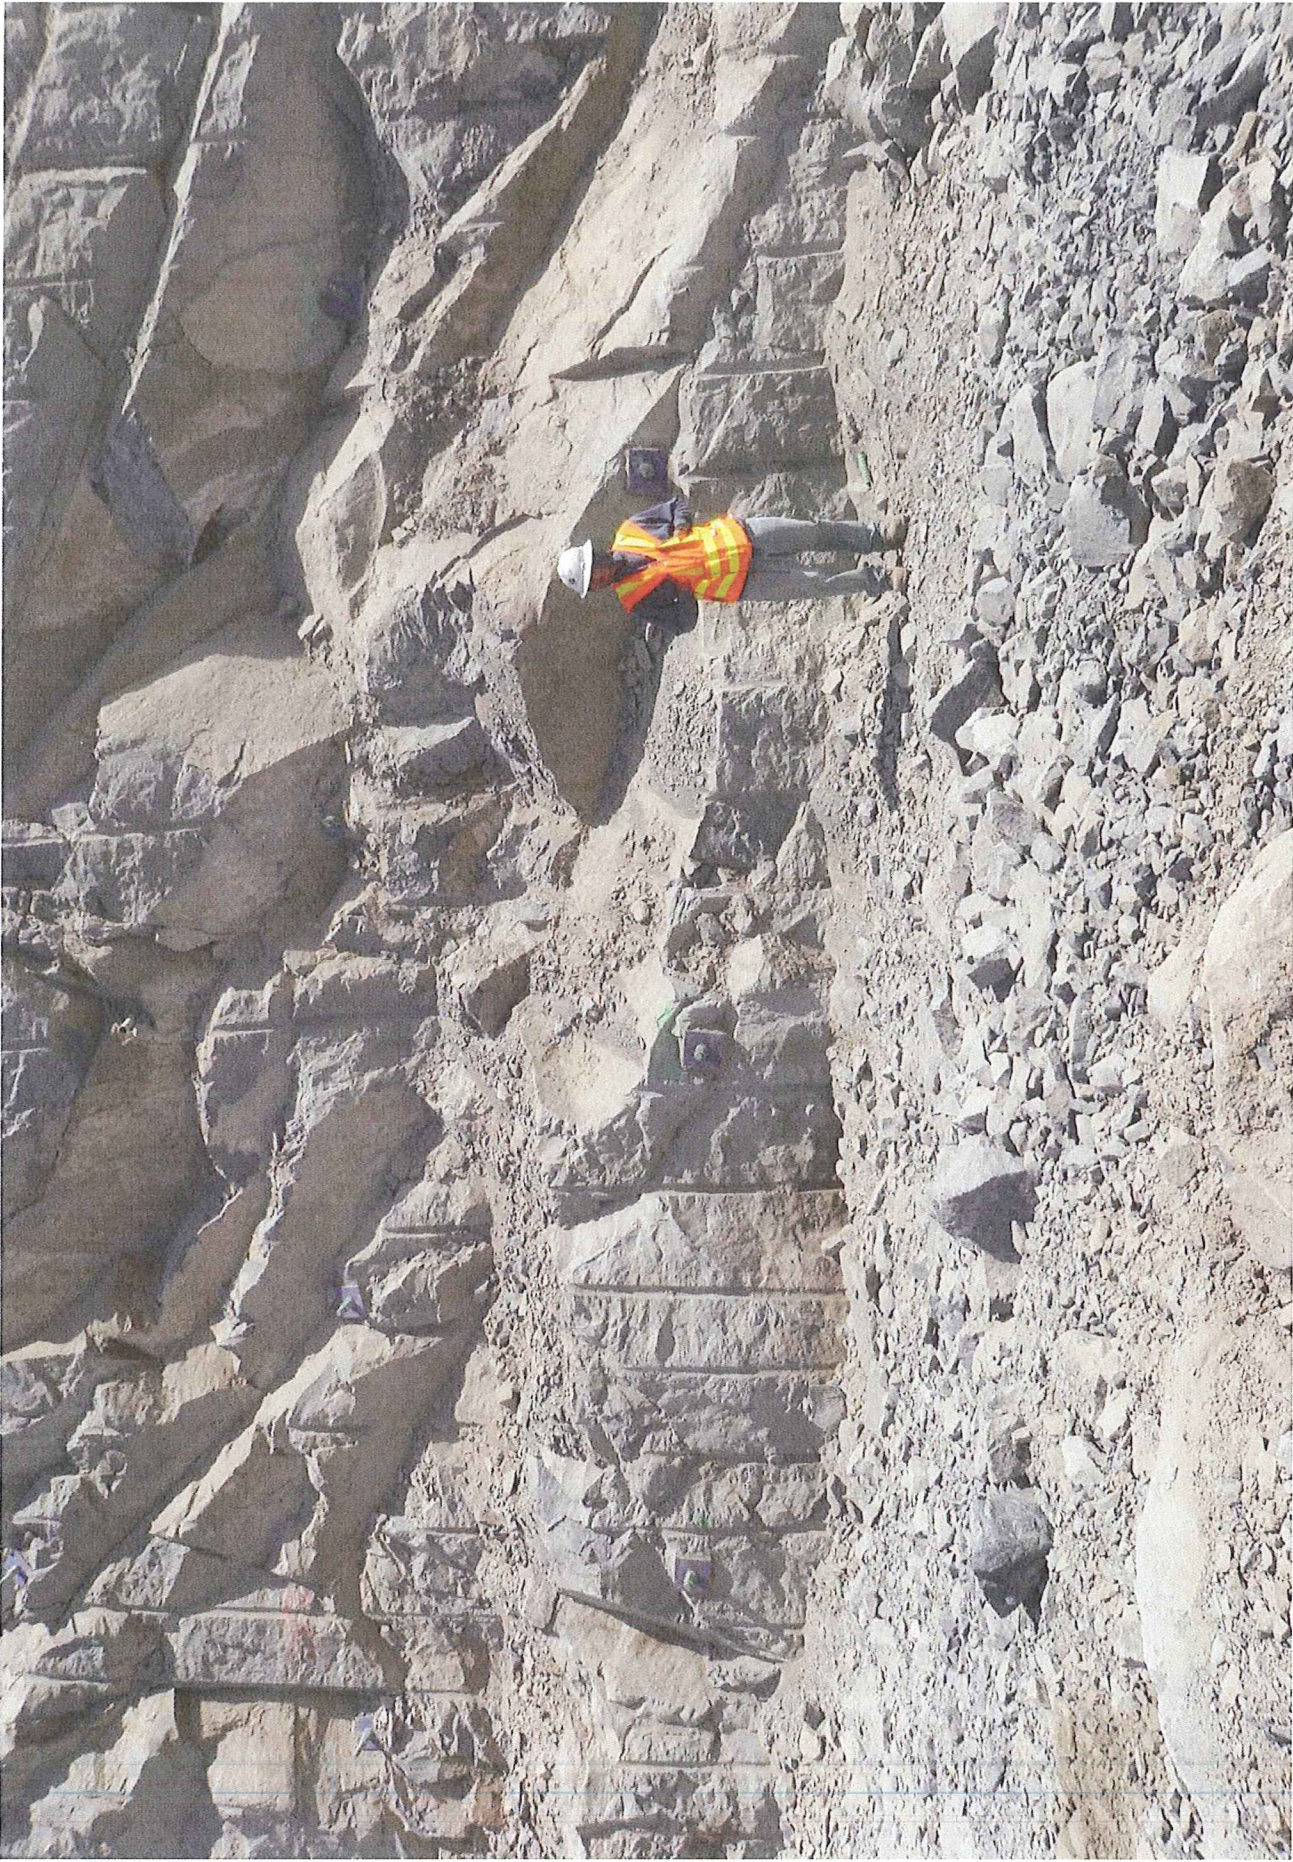
From about LW Sta. 1332+00 to 1338+00, we were able to see the first 12 foot lift removed from bench 4 of last year's preshear and the results are mixed. In some areas the preshear developed well, in others it is very poor and lacks any evidence of drilling being done at a consistent spacing or in the same plane (Figures 6 and 7). Brad Schut indicated that he would be measuring out all of the preshear line holes through this section and it didn't

Figure 6. A photograph of the recently exposed preshear on Bench 4 from last year's blasting between approximately Station 1332+00 to 1338+00. This is an area that displays good drill control and preshearing of the face.

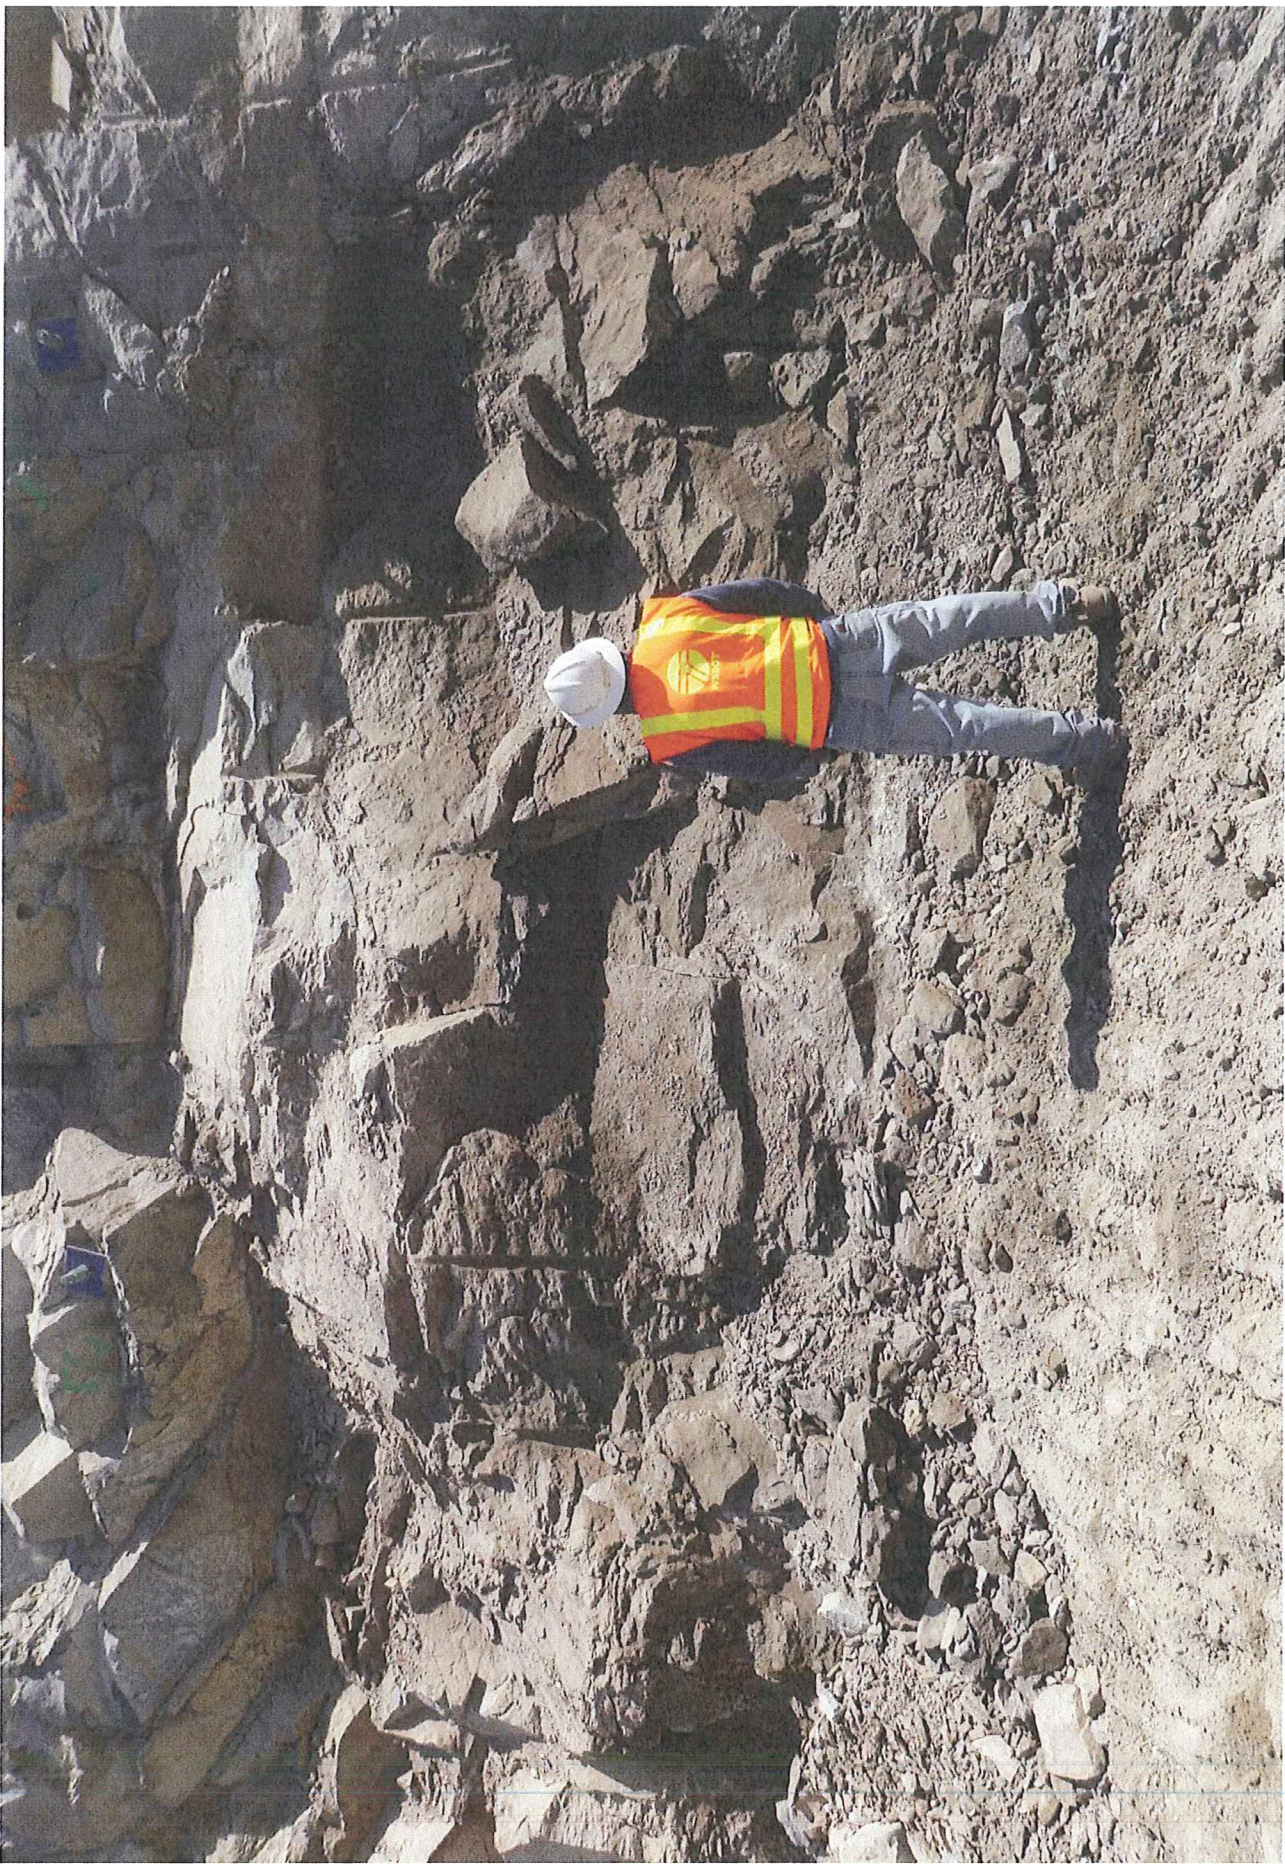
look like they were going to get paid for many of them. I agreed. Brad Collier did not comment, nor did he give any indication that he really want to talk about last year's drilling efforts.

Figure 7. A photograph of the recently exposed preshear on Bench 4 from last year's blasting between approximately Station 1332+00 to 1338+00. This is an area that displays terrible drill control in and out of the slope and parallel to the slope, resulting in poor preshearing of the face.

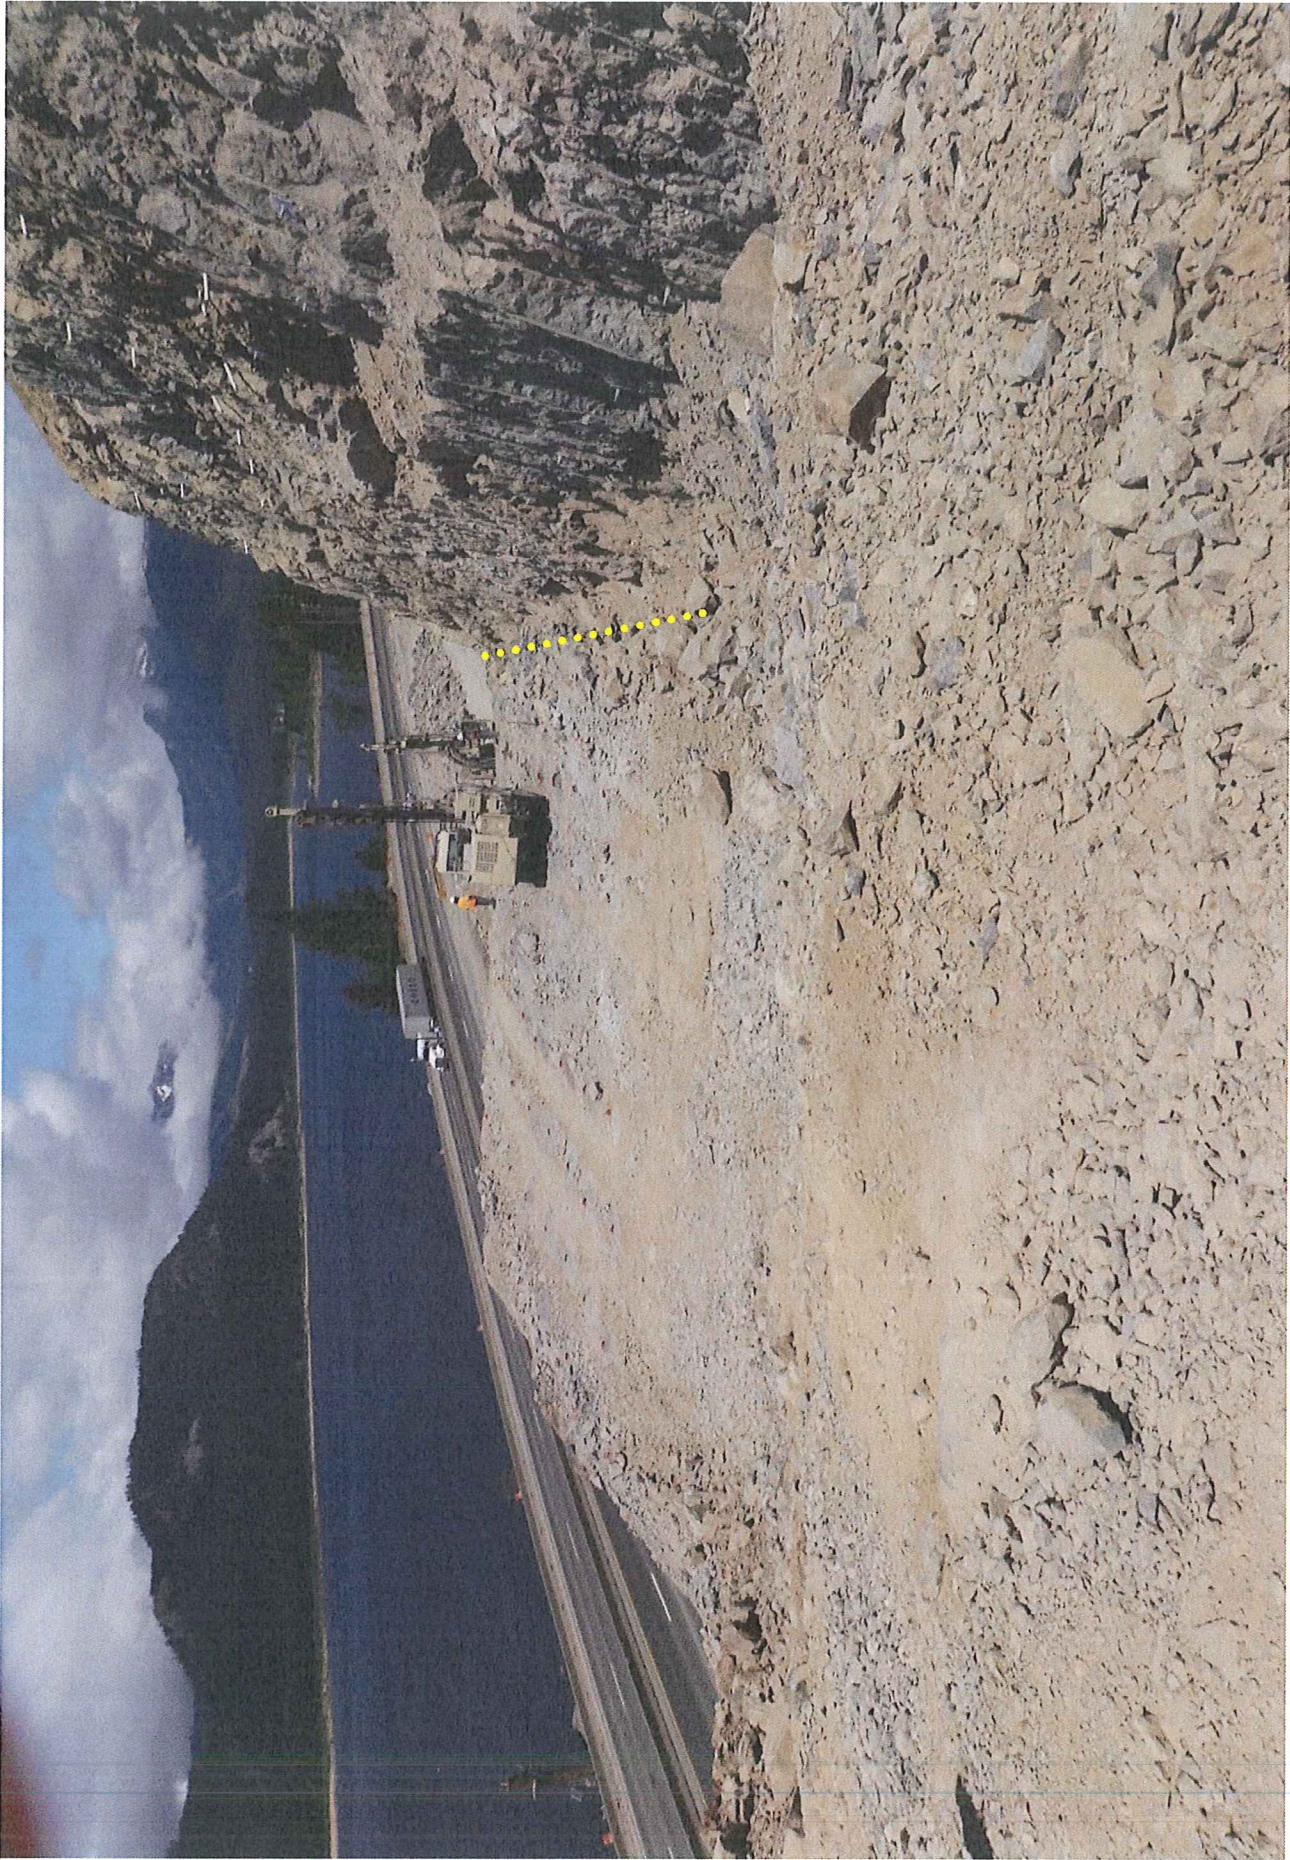
Brad Collier and I looked at the section that was being drilled out for production that night from approximately LW Sta. 1329+25 to 1330+25 (Figure 8). I noticed that the surface of the preshear looked very defined (cratered) and asked Brad if he usually gets such good definition at the surface from the preshear. He said that he has recently changed the way he is stemming the holes to an alternating pattern of 4 feet followed by 8 feet, etc... He said that it is providing more definition of the preshear blast while not uplifting all the rock immediately in front of the preshear creating a difficult situation to collar in the holes for the first production (buffer) row.

Figure 8. A photograph taken looking northwest at LW Sta. 1329+25 to 1330+25, where the Contractor is drilling for a production shot tonight. It is difficult to see in this photograph, but notice the cratered preshear line near the back slope (yellow dotted line).
